EWS Newsletter

Early Warning System Program
News and Announcements

Early Warning System Program Adopts Webcam Technology

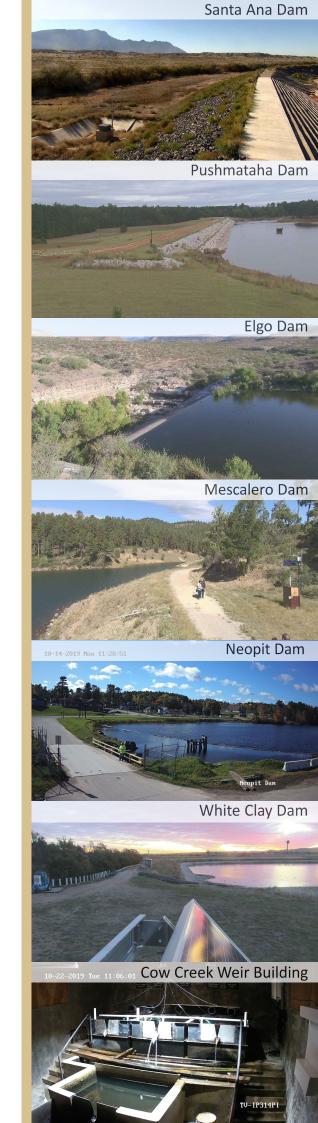
Seven cameras were installed to monitor dams on Tribal lands this year. These cameras take images of a dam every five to fifteen minutes, and transmit the images to the EWS website using either local Wi-Fi or Verizon's cellular data network. Some example images are shown to the right.

The cameras are off-grid and powered by batteries. These batteries are recharged by a solar panel during the day. The cameras have Pan-Tilt-Zoom (PTZ) lenses, and Infrared (IR) technology for viewing images taken at night.

Real-time camera images are sent over Verizon Wireless Cellular data via a LTE Wireless Gateway to be displayed in the EWS

All images taken from the camera are stored and accessible on the EWS camera website. Timelapse videos of the images at a dam are automatically created in two formats: a daily timelapse that is stored for 60 days, and an ongoing historical snapshot timelapse of every day at a specific timestamp for the lifetime of the camera.

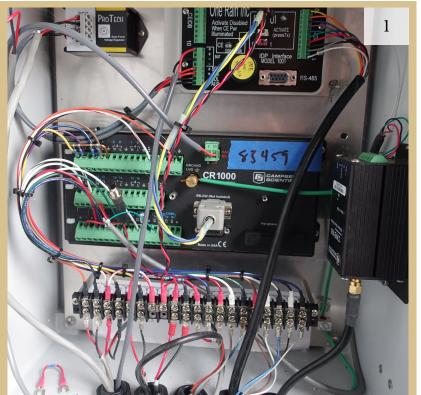
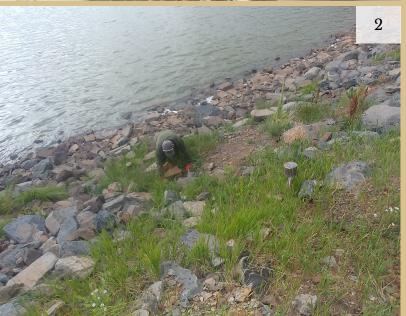
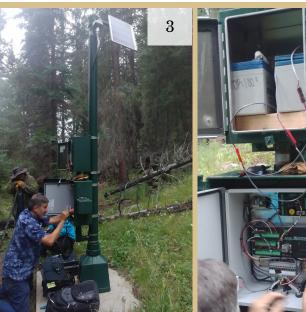
Images from top to bottom, left to right:

- 1) completed two-way datalogger installation
- 2) checking the pressure transducer functionality at a dam site
- 3) updating the datalogger software at an EWS site
- 4) checking the wire connections and batteries at an EWS site

In 2017, the code managing data within the datalogger was updated to have "two-way" capability. This means new configuration files can be remotely uploaded to the datalogger through the satellites. This increases a user's control over the sensors without physically visiting the site. Additionally, the sensors can be remotely queried to assess their status and functionality, allowing diagnostics and testing without traveling to remote locations.

There were over 40 two-way EWS backplane upgrades in 2019, with the entire EWS planned to be switched over to the new technology within the next few years.

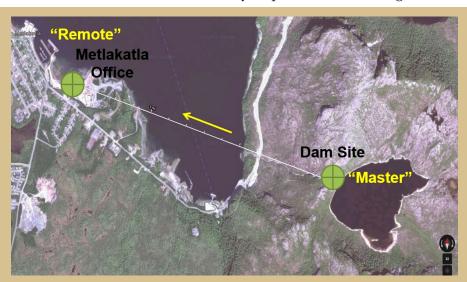
Left: Installation site location map for the new EWS system at Chester Lake. Right: Helicopter flying in equipment for the new EWS site

The only access to the dam is along a steep rugged trail, which makes the data especially valuable during hazardous weather conditions. To get equipment to the installation site, a helicopter was used to lift a tote to the dam (see above picture on the right).

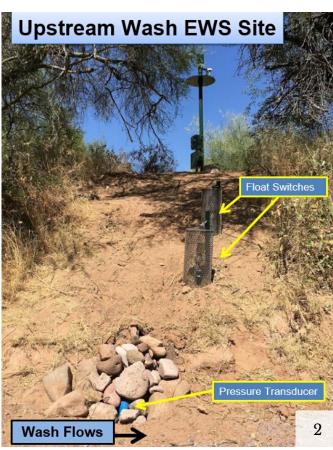
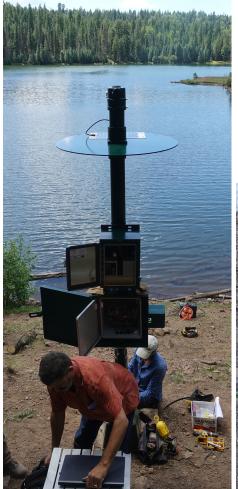
Earl Park Dam EWS Installation

Verifying the data from the Earl Park EWS Concrete baseplate for Earl Park's EWS Site

EWS site installation for Earl Park

Earl Park Dam was recently added to the SOD Program, and a new EWS site was installed. During the installation, the BIA worked in partnership with the White Mountain Apache Tribe to finish updating all of the dataloggers and float switch technology to the latest two-way technology for the EWS entire system on the reservation (see pictures below).

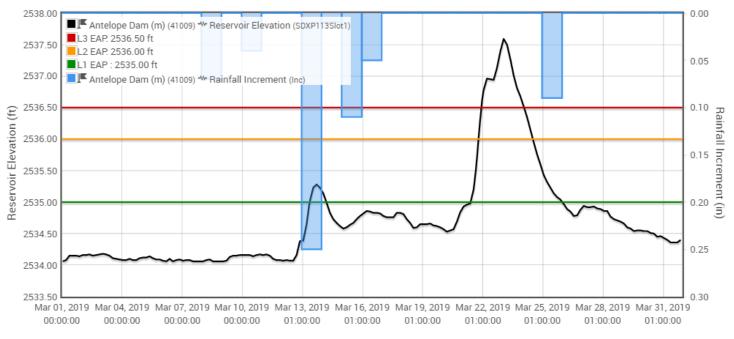
Data plot from the EWS illustrating all three EAP threasholds crossed at Antelope Dam during the event

In March of 2019, the Great Plains Region, including the Rosebud Sioux Reservation, experienced a large flood event. Subsequent snow accumulation created blizzard conditions after the rainfall event. The flooding triggered EWS alarms at multiple dam sites, and the Tribe initiated the appropriate emergency response.

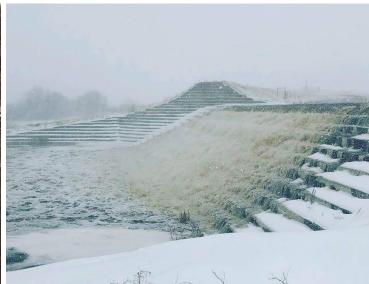
Dam spillway activated during the event

Rosebud dams appear to have operated as intended. Several spillways activated during the event and increased downstream flooding.

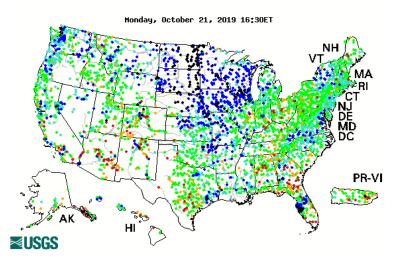
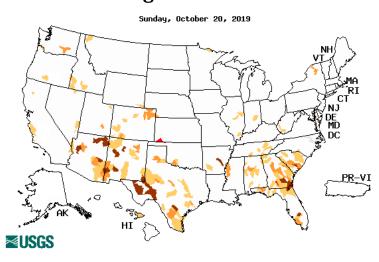
Streamflow Conditions

Drought Conditions

Explanation - Percentile classes								
•	•					•		
Low	<10	10-24	25-75	76-90	>90			
Low	Much below normal	Below normal	Normal	Above normal	Much above normal	High

Explanation - Percentile classes									
Low	<=5	6-9	10-24						
Extreme hydrologic drought	Severe hydrologic drought	Moderate hydrologic drought	Below normal

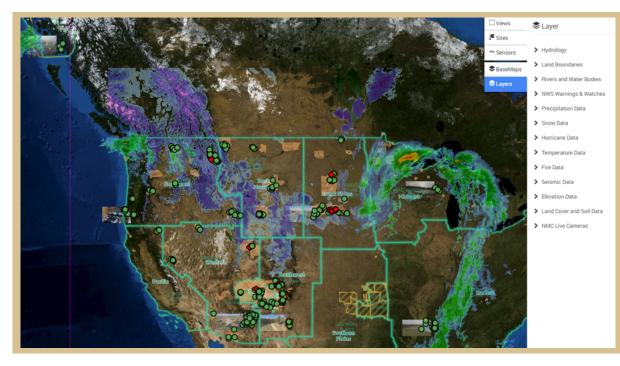
Multiple layers turned on within the EWS map to help understand hydrologic conditions

- Contributing watersheds for the dams (1)
- Tribal land area representations (LARs) (2)
- BIA office locations and regional boundaries
- Precipitation radar grids (4)
- Quantitative precipitation estimates (QPE) (5)
- Average annual precipitation and temperature
- Flooding (3), precipitation (6), temperature (9), drought (7), and wildfire outlook forecasts
- Snow water equivalent (SWE) Grids (8)
- Hurricane data forecasted Eastern Pacific and Atlantic/Caribbean hurricane tropical storm paths (12)

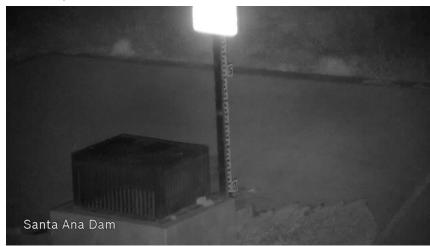
Santa Ana Dam's camera image at night can read the staff gage

Some of the cameras have captured wildlife (a bobcat was spotted at Santa Ana Dam, pictured top-right) people fishing, cows grazing (bottom image), changing weather conditions -- all caught on camera! The images look great at night and capture enough detail to even read a reservoir staff gage (second image from the top).
